GENERAL INFORMATION

Pentium® II Xeon™ Processor and Boxed Pentium® II Xeon™ Processor Markings

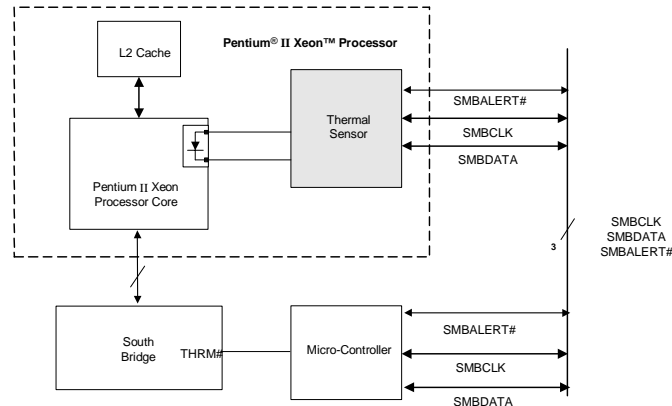
Figure 1. An Example of Microcontroller Driven Thermal Management

Problem: The Pentium II Xeon processor has a thermal sensor that monitors the processor core's temperature. The thermal sensor asserts SMBALERT# if the processor temperature exceeds the temperature limits set in the Alarm Threshold Registers (T_{HIGH} , T_{LOW}). It also sets the corresponding Status Register bits to identify the cause of the interrupt. Figure 1 gives one example of the how the SMBALERT# signal could be used in a system.

Under the conditions described below, the thermal sensor incorrectly generates the SMBALERT# interrupt. All of the following conditions must be met to trigger a false interrupt:
